**Phase I
Environmental Site Assessment Report**

Old Marienville Compound
Route 66 & Popular Street
Marienville, Jenks Township, Forest County, PA
For

**U.S. Department of Agriculture, Forest Services
Allegheny National Forest
222 Liberty Street
Warren, PA 16365**

February 9, 2007

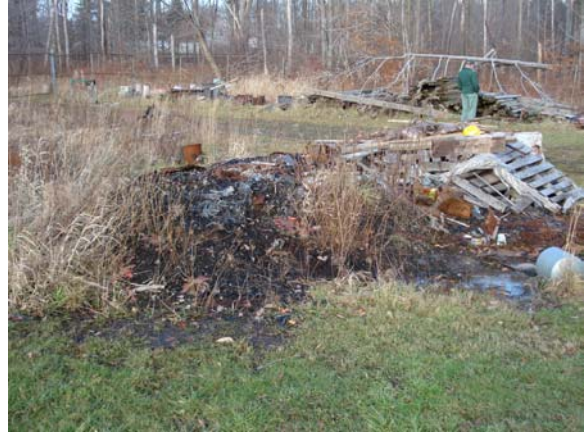
Storage Area Burn Pile

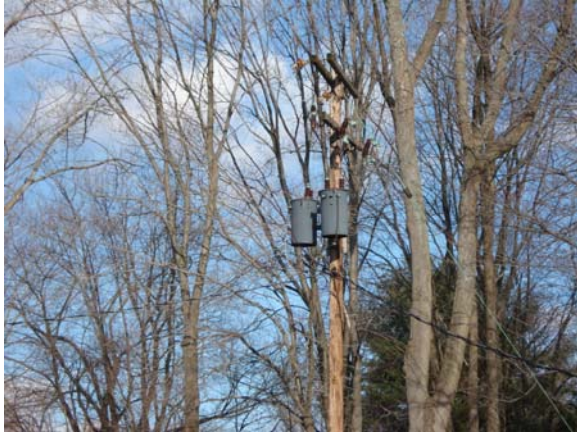
Transformers on East Property

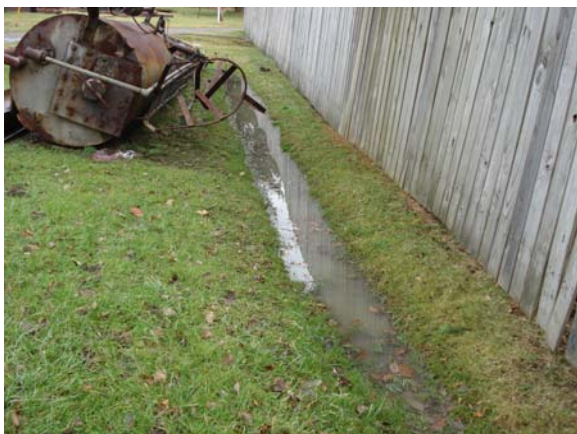
- The property was bordered by the Knox Kane Railroad.
- The surface drainage appeared to flow to the south and towards the property.
- Standing surface water was observed along the north side of the fence separating the properties. The standing water did not contain odors and appeared free of visible contamination.

Surface Water on North Side

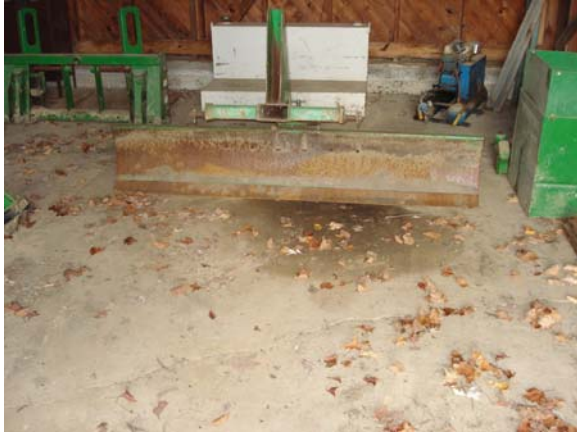
- The interior floor of the building was finished with concrete. The interior wall and ceiling surfaces were unfinished.
- The concrete floor on the east bay contained light staining on the center of the floor, which appeared to be oil.

Light Staining on East Garage Bay

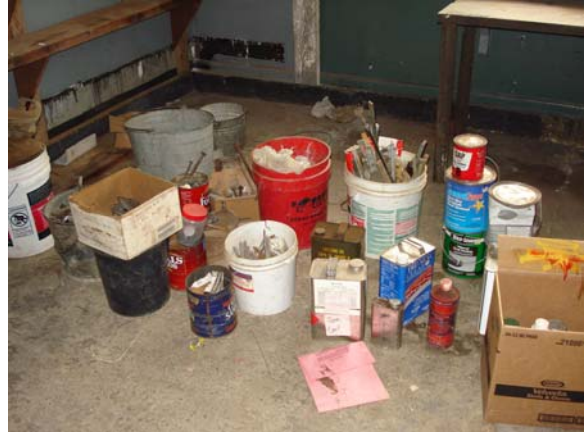
- The interior floor was finished with concrete. The walls were finished painted wood paneling. The ceiling was finished with 4' x 2' tiles.
- The storage room on the north side of the building contained several containers of paint-related materials. The cans appeared to be intact with no signs of leakage.

Paint Related Material on Shop Floor

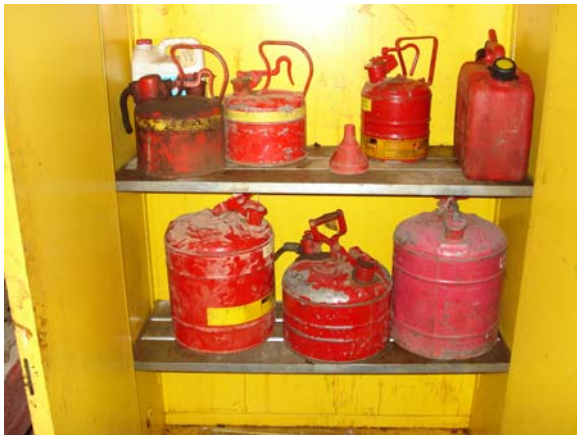
- There was a flammable liquids storage cabinet, which contained 2 gallon and 5 gallon metal cans of miscellaneous fuel and fuel/oil mixtures. The floor around the cabinet was free of visible staining.

Flammable Liquids Storage Cabinet in Garage

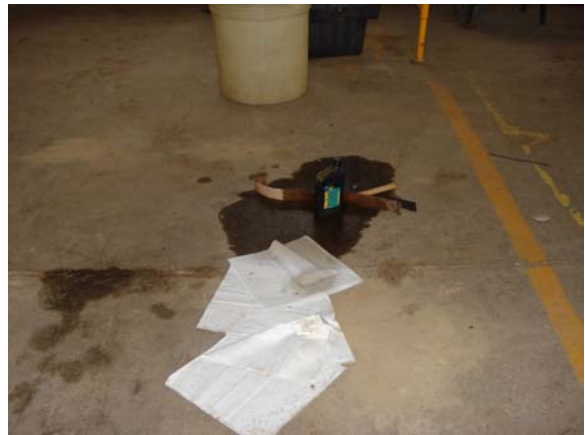
Oil Stain on Shop Floor

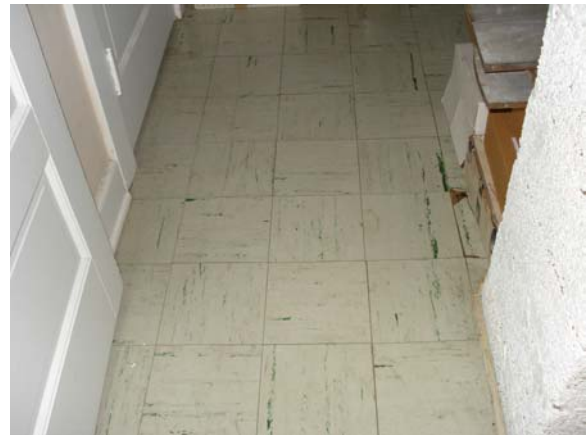
- The 9" x 9" floor tiles and mastic were found to be ACM. The total area of ACM was ~785 square feet.
- The estimated cost to remove the ACM from the building is \$1,800.00. This price would include the required monitoring, removal, and subsequent disposal into an EPA approved landfill, in accordance with Federal, State, and Local regulations.

Duplex – Second Floor 9” x 9” Tile –
Possible ACM

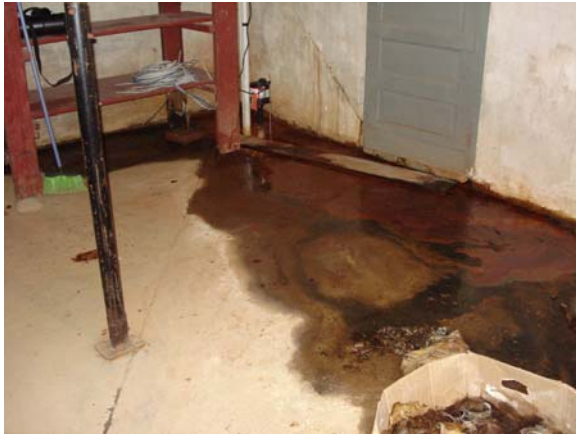
- Water and water staining was observed on the floor on the south east and west sides of the room. The water appeared to have originated from around the sump pump.

Duplex Basement – Water Backup near Sump

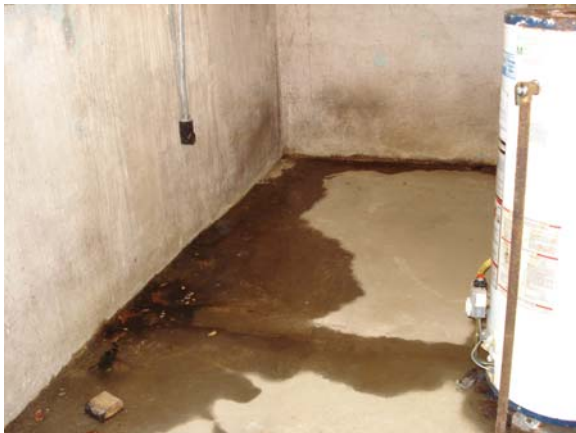
- There was light staining on the CMU that appeared to be visible mold.
- Based on the age of construction, interior finished surfaces (flooring, wall panel, insulation, and caulking) may contain ACM and LBC.

Duplex Basement – Standing Water and Light Visible Mold on Wall

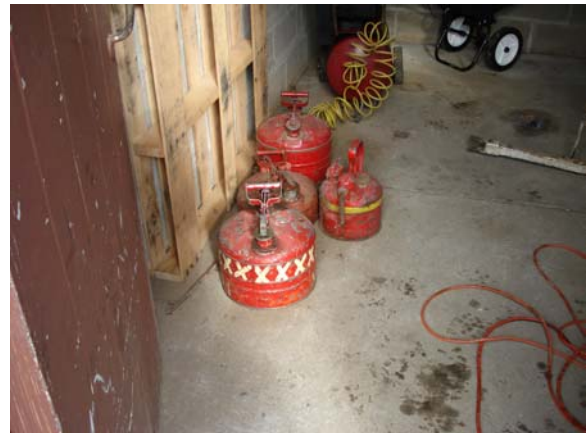
- The sump pit located in the floor contained a few inches of standing water. The water was free of odors and visible contamination.
- Several fuel cans and three lead acid batteries (automotive size) were located on the floor. The cans felt empty when lifted and there were no signs of staining on the concrete floor around the cans or batteries.

Utility Building – Fuel Cans

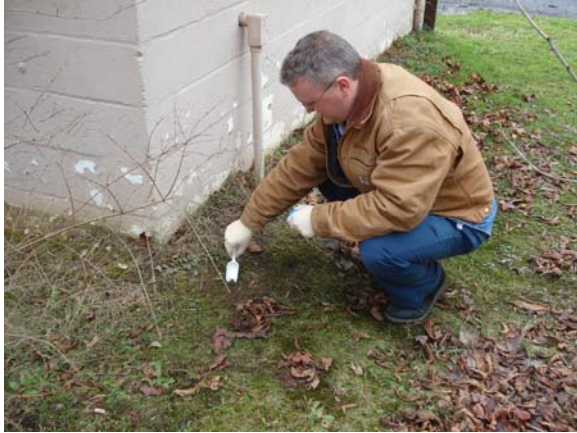
- Lead Based Paint (LBP) was found on the exterior and interior surfaces throughout the structure.
- Lead concentrations of 462 mg/kg were found in the soils below a drip line on an exterior wall.

Utility Building – Soil Sampling for Lead

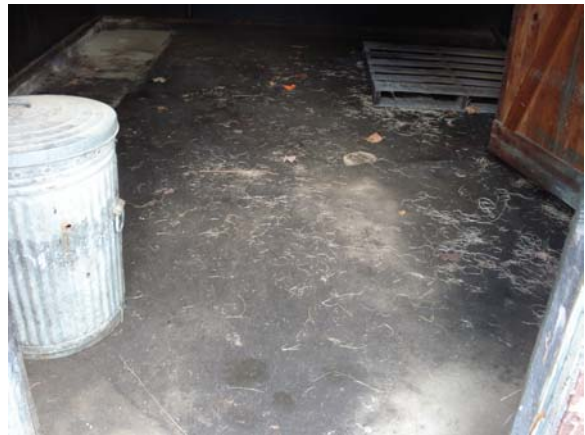
- The building was approximately 12' x 16' and, according to ANF records, was built in 1940.
- The exterior of the building was finished with painted CMU. The roof was finished with three-tabbed asphalt shingles. Based on the age of the building and the degradation of the shingles, the shingles are likely ACM.
- The paint covering the CMU was heavily degraded and peeling. The paint could possibly contain LBC.
- The surfaces around the exterior of the building were free of petroleum odors and visible staining.
- The interior floor consisted of concrete. The walls were finished with wood panels and the ceiling was unfinished.
- The surface of the concrete floor contained heavy oil staining.

Oil House – Stained Floor

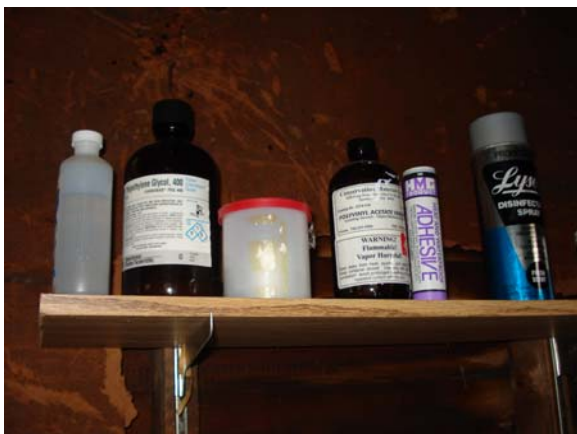
- The building was approximately 12' x 16' and according to the ANF records was built in 1940.
- The exterior was finished with CMU and the roof was finished with three-tabbed asphalt shingles. Based on the age of the building and the degradation of the shingles, the shingles are likely ACM.
- The paint covering the CMU was heavily degraded and peeling. The paint could possibly contain LBC.
- The interior floor consisted of concrete. The walls were partially finished with pressed fiberboard. The ceiling was unfinished.
- The exposed CMU walls were cracked with some areas open to the outside.
- Staining was observed to the decking and trusses on the unfinished ceiling.
- The shelves on the north and south wall held small containers of Carbowax (polyethylene glycol) and varnish (polyvinyl acetate).

The containers appeared to be intact and there was no staining to the floor or shelving around them.

Varnish and Carbowax on Shelf

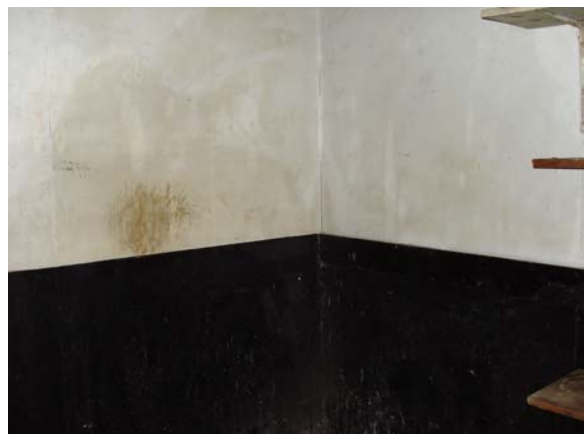
Oil House – Light Staining on Walls
